Manhole Inspection Summary

Manhole # S15C1_009MH

Insp Date: **5/27/08 8:21 AM**

Location Address: **1711 casadel av**

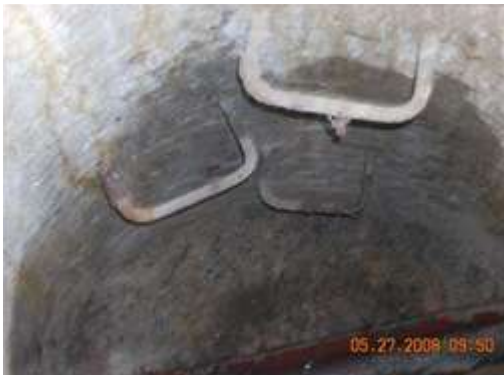
Defect 5

Steps Count: **3** Missing: **0** ☒ **Corroded**

corroded steps

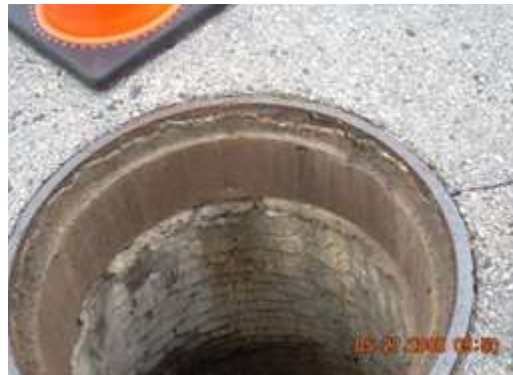
Defect 4

☐ Prev. Rehab Weather: **Light Rain** Subject To Ponding: **Sheeting**

inflow evidence from sheeting

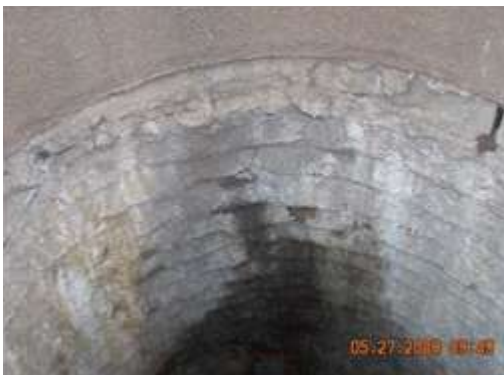
Defect 3

Infiltration: ☐ None ☒ **Joint** ☐ Cracks ☐ Mortar ☐ Roots ☐ Wall

infiltration @ chimney/frame joint

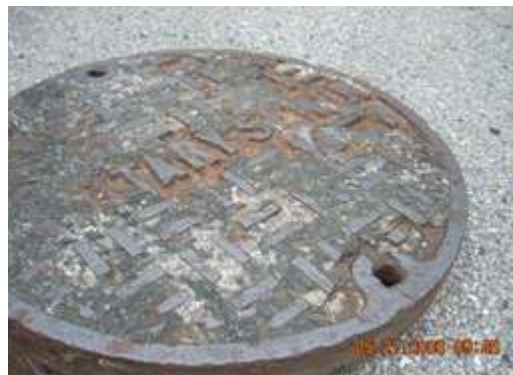
Defect 2

Type: **Sanitary** Condition: **Worn** Cover Material: **Cast Iron**

worn cover

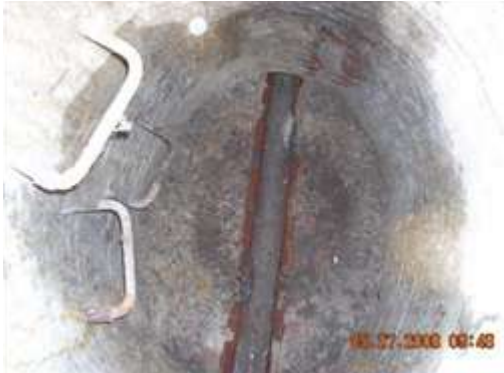
Defect 1

Infiltration: ☐ None ☐ Joint ☐ Cracks ☐ Mortar ☐ Roots ☒ **Wall**

Barrel Flow Wall
